Products tested	VCCR300-xx
Products Description	300W DC-DC power supply.
Design Phase	3 – Verification
Product Serials	P/N: VCCR300-24, S/N: 2328CXX0004 P/N: VCCR300-36, S/N: 2328CXX0006
Test Goals	Test according to MIL-STD-810G: Method 503.5 Procedure I-C
Test dates	13 <sup>th</sup> July to 9 <sup>th</sup> August 2023
Report date	14 <sup>th</sup> August 2023

# 1. Objective

Thermal Shock testing is an optional test requirement to comply with MIL-STD-810G standard. The objective of this report is to show compliance with the requirements of MIL-STD-810G: Method 503.5 Procedure I-C.

**THERMAL SHOCK TEST FOR VOX POWER IN ACCORDANCE MIL-STD-810G:  
METHOD 503.5 PROCEDURE I-C.**

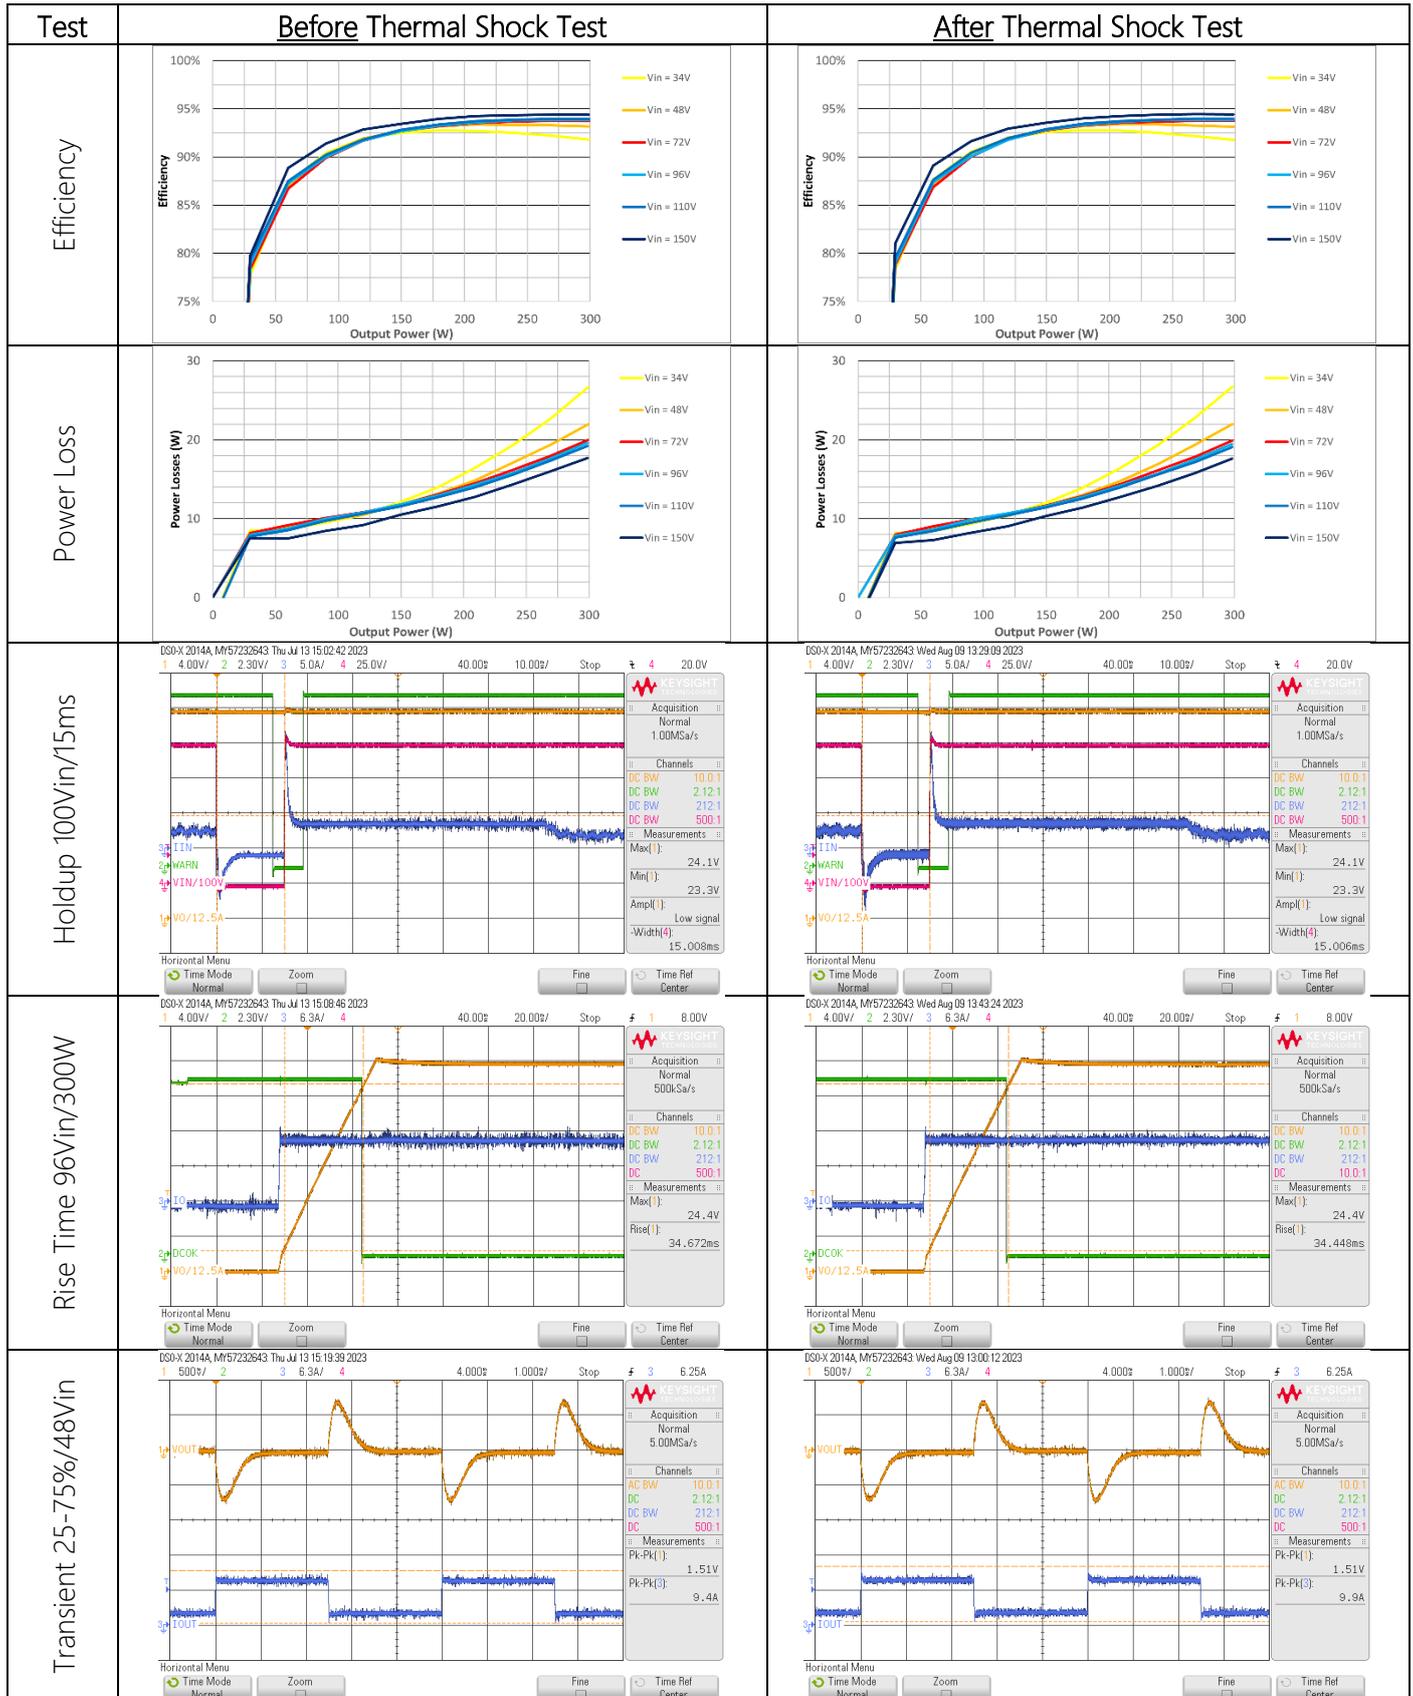
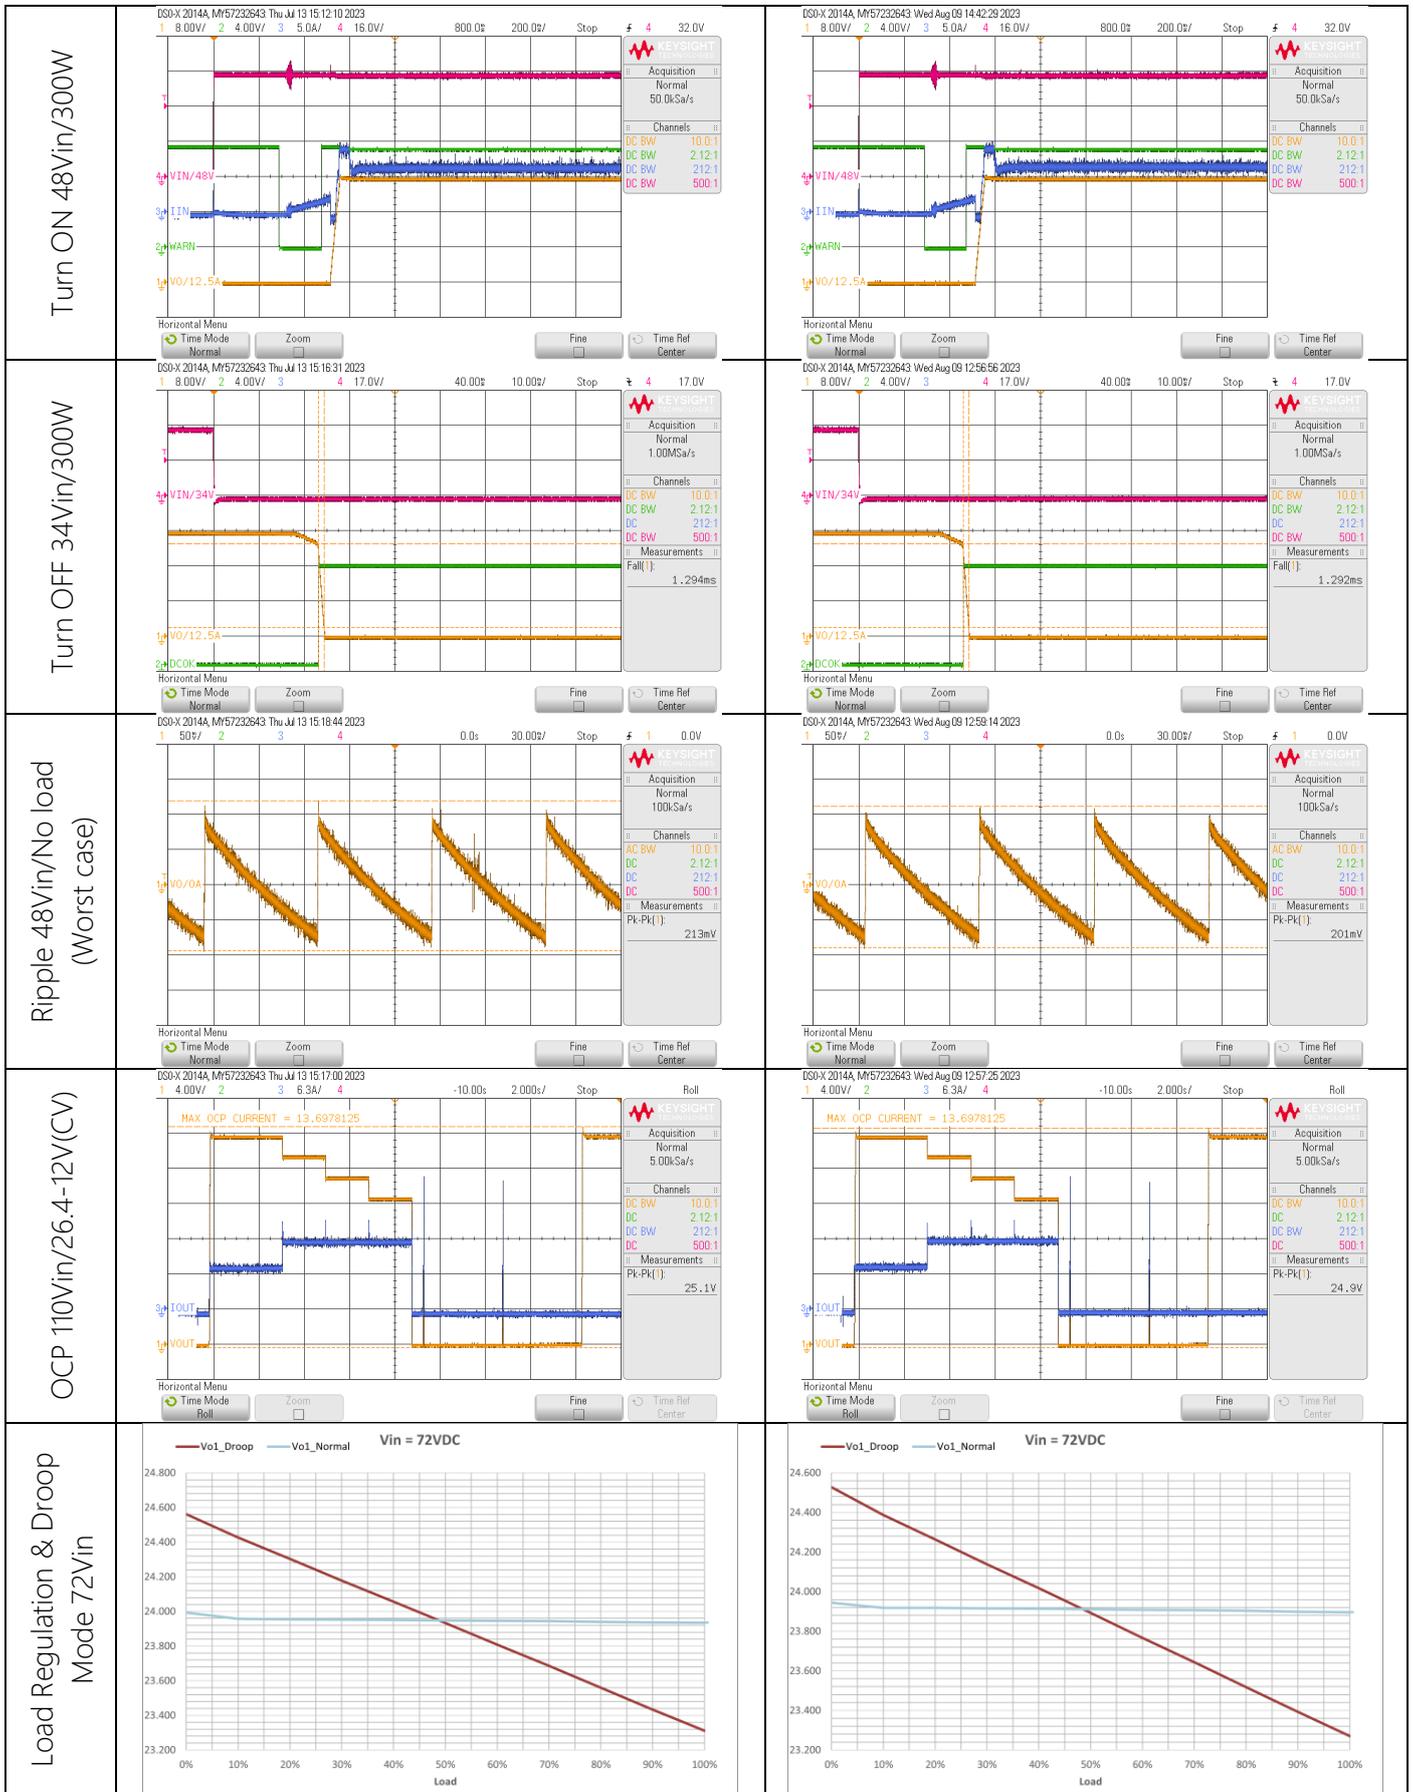
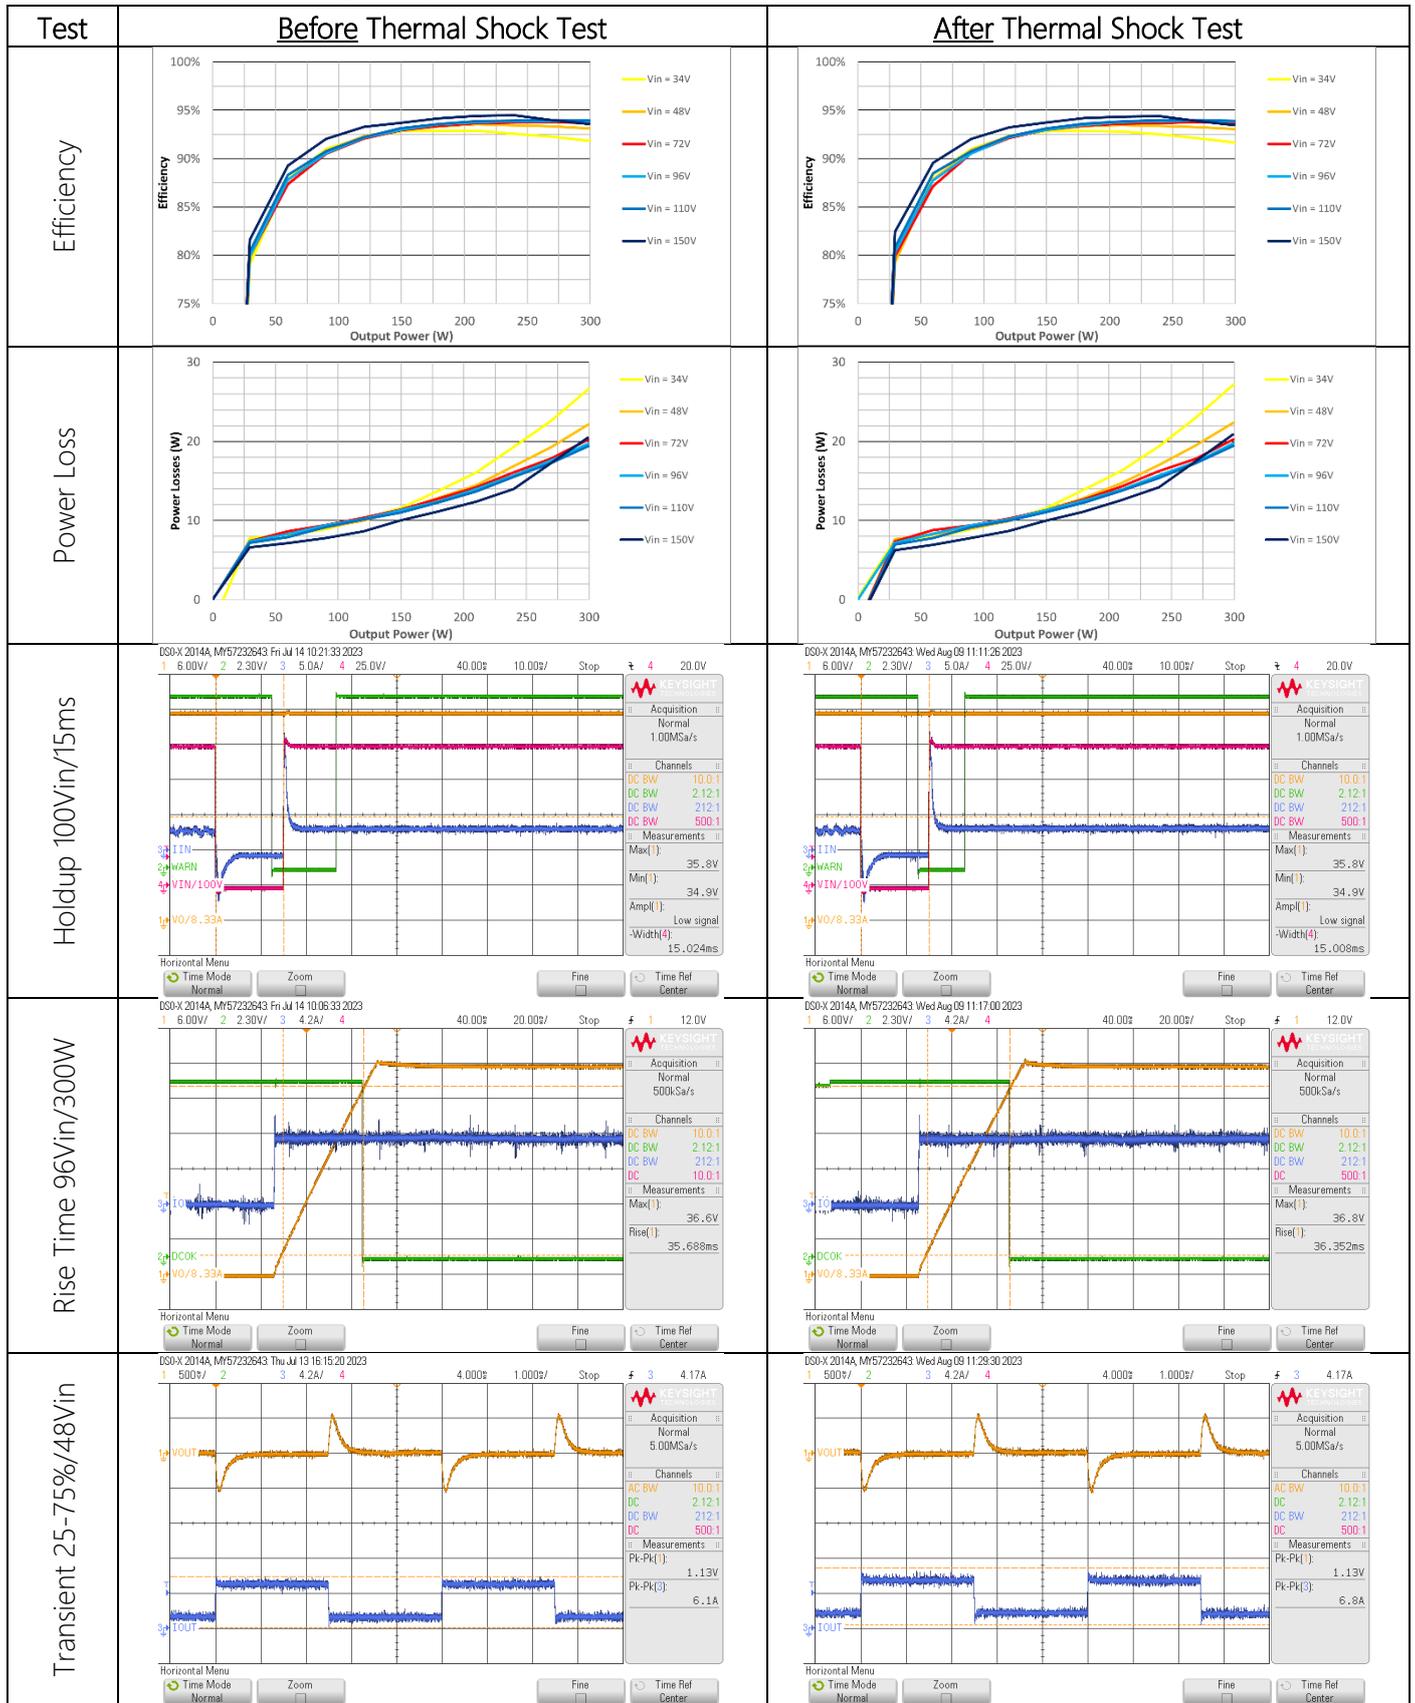
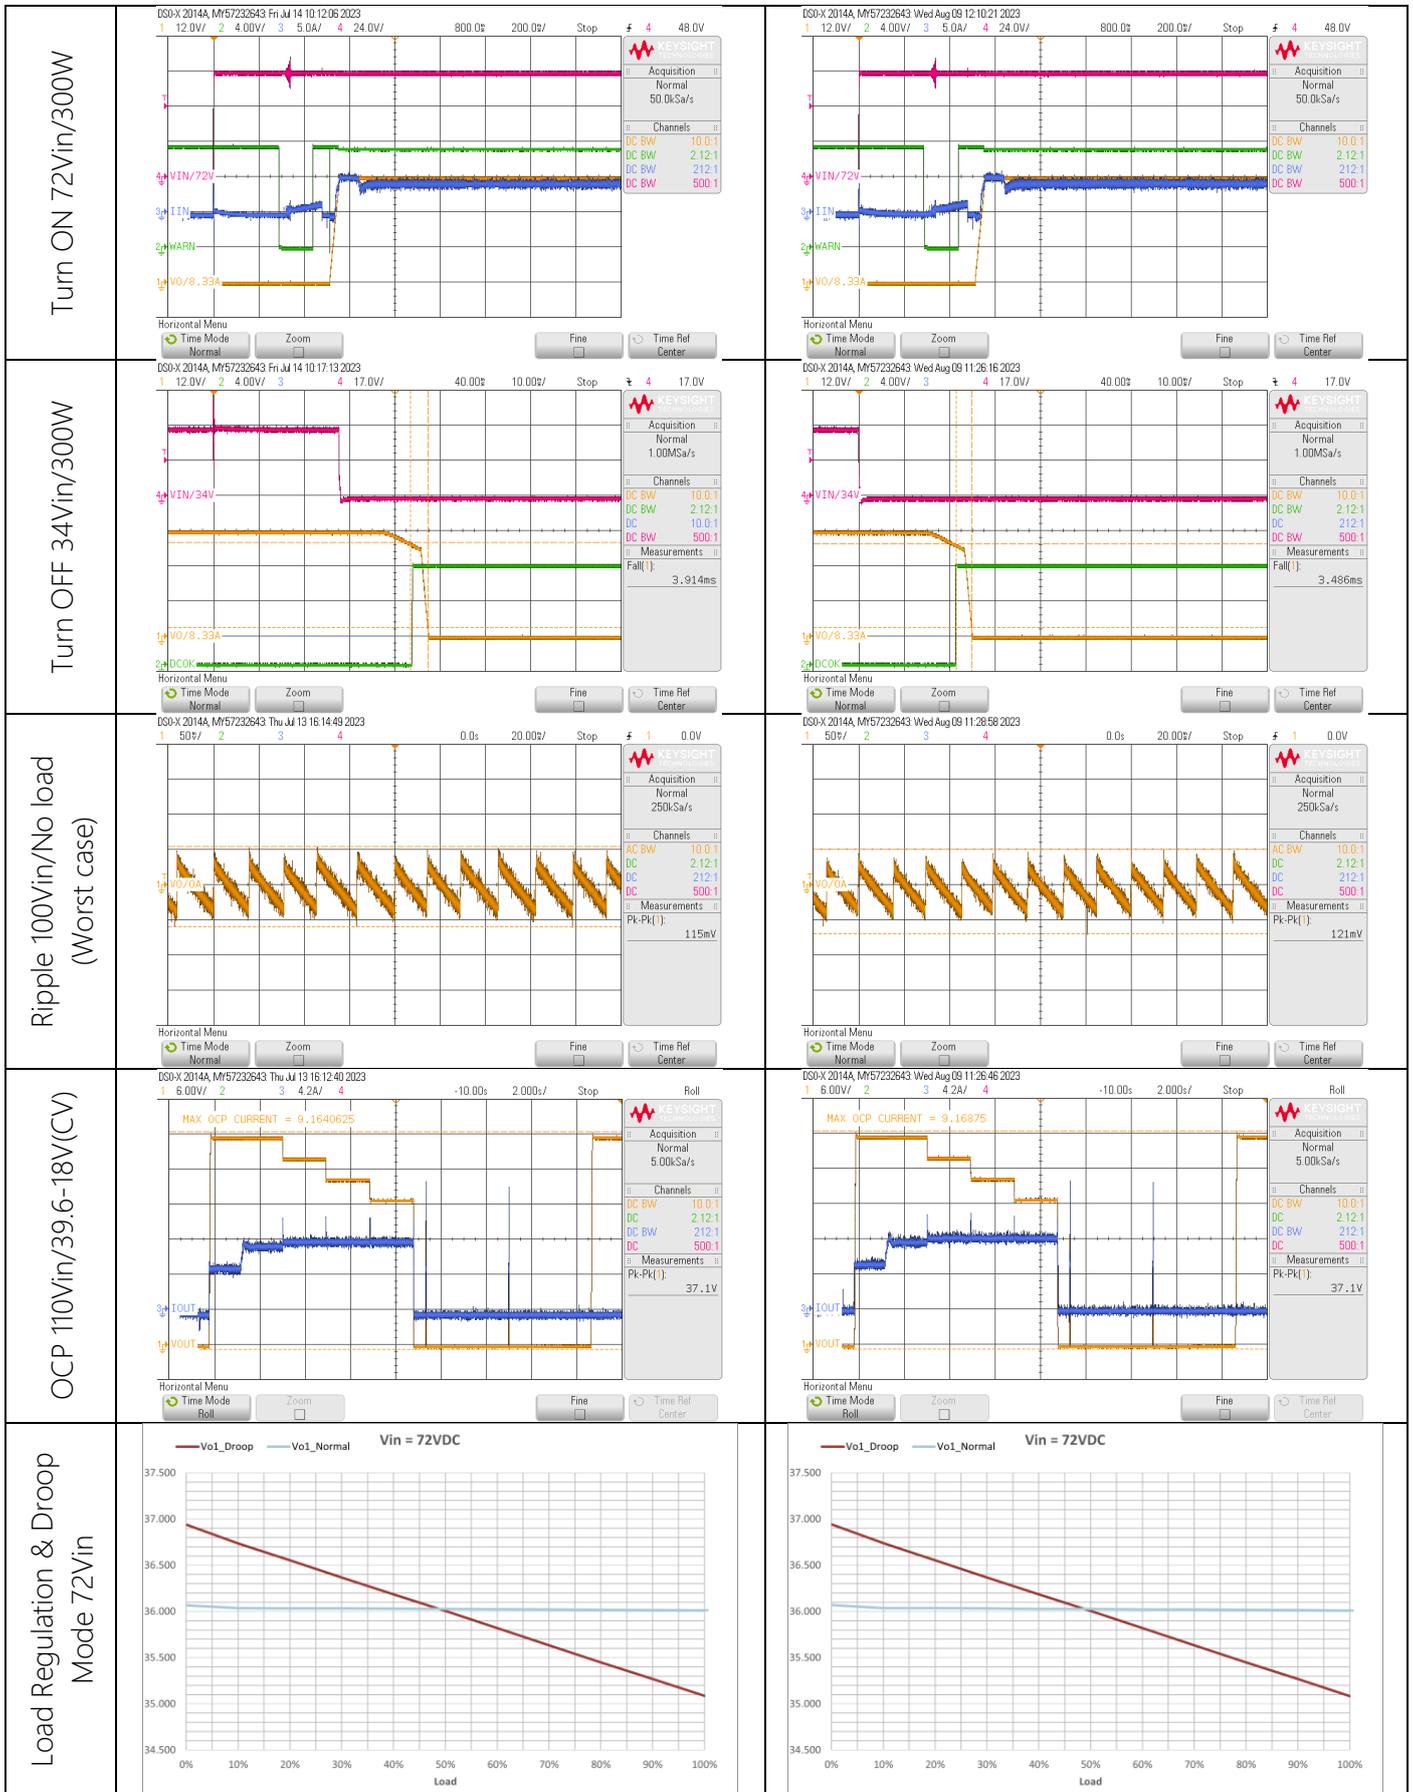
VCCR300-24 Engineering Sample, S/N: 2328CXX0004

The details of the performance tests before and after testing are shown in appendix 1.

The performance test results for the tested samples before and after the thermal shock test show no variation in performance.

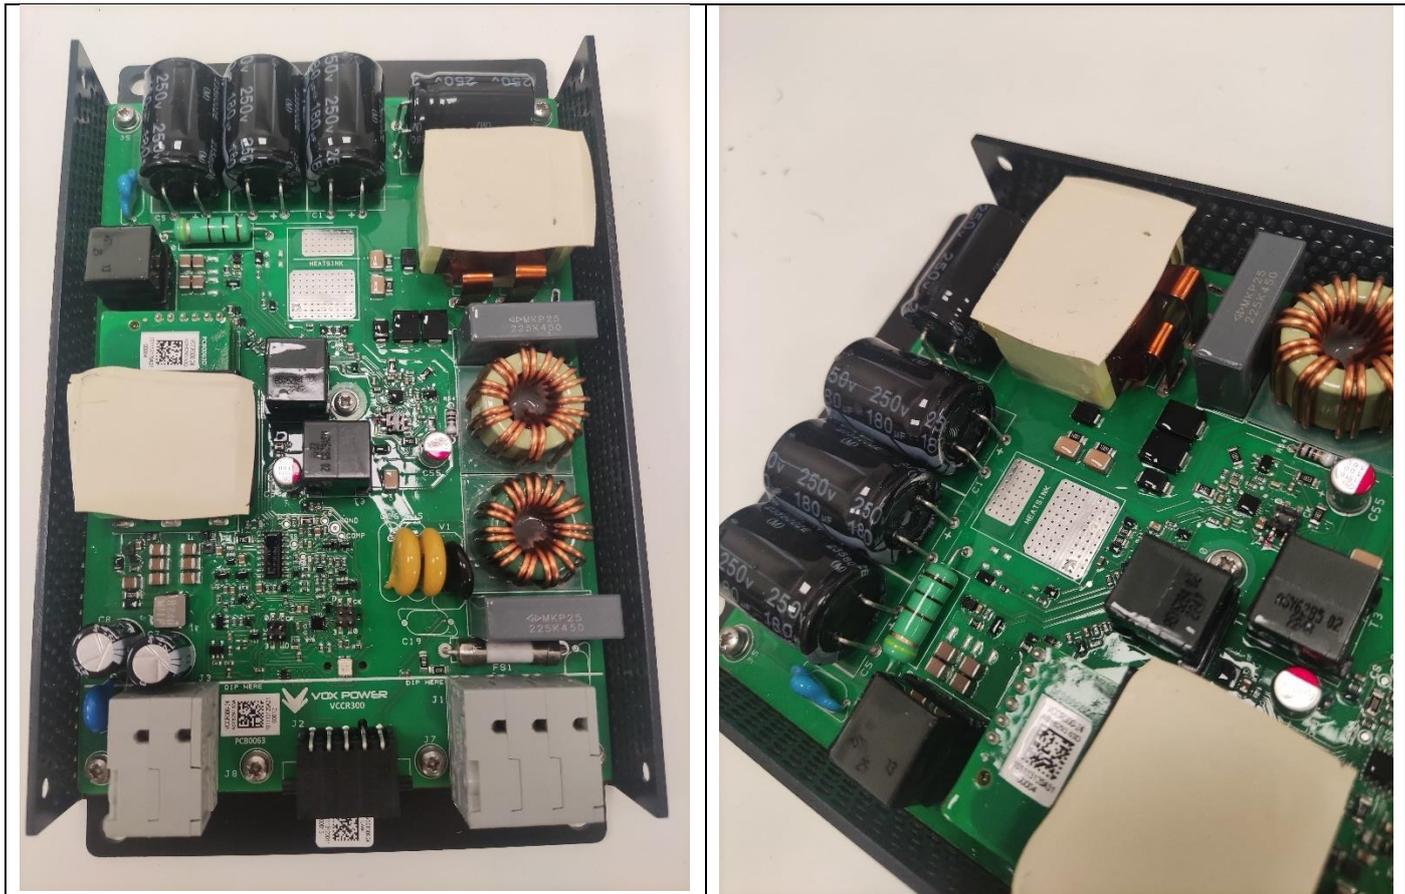
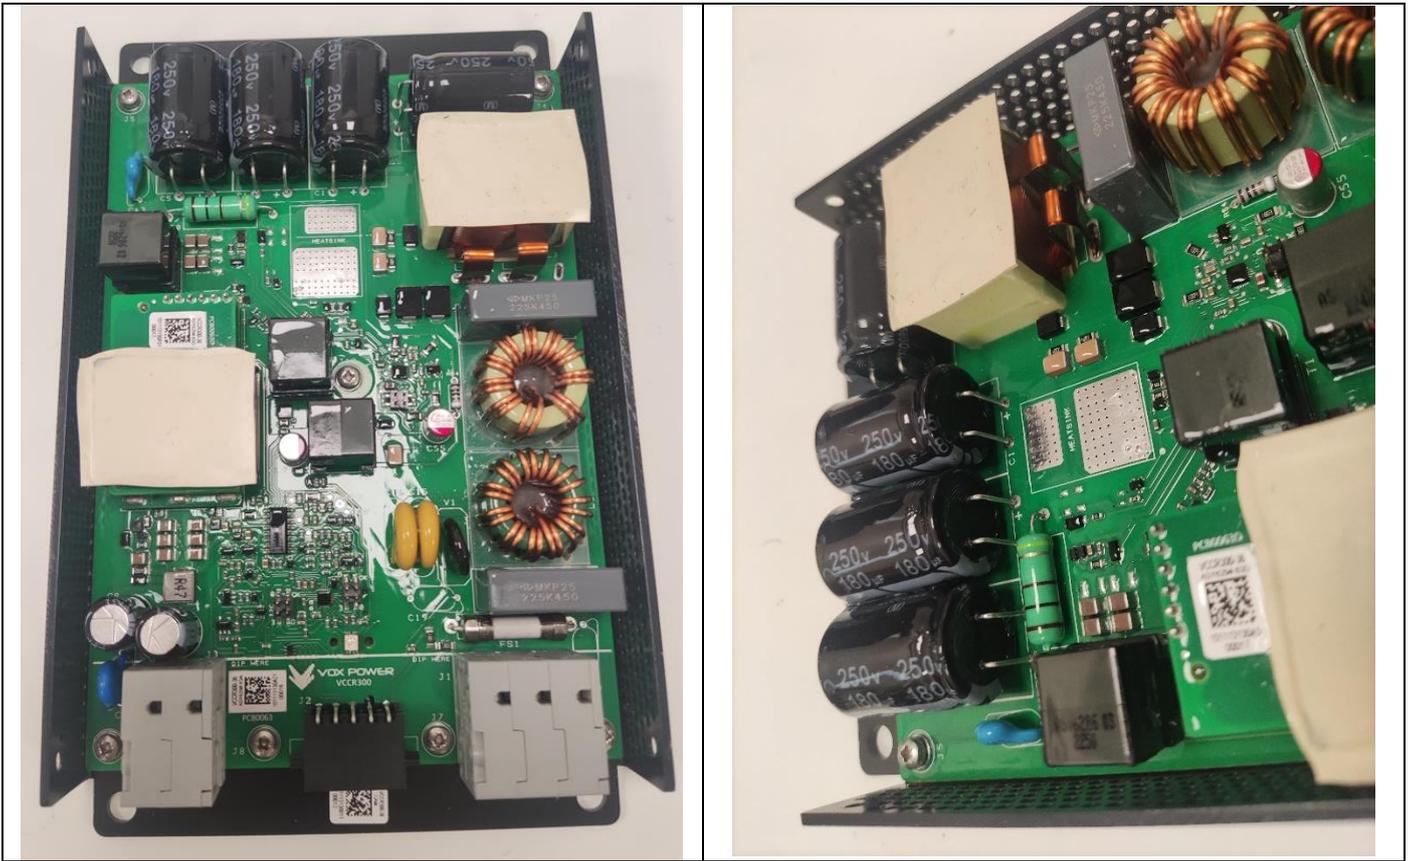
VCCR300-24 Engineering Sample, S/N: 2328CXX0004

The details of the visual inspection are shown in appendix 2.

The visual inspection does not show any damage or issues.

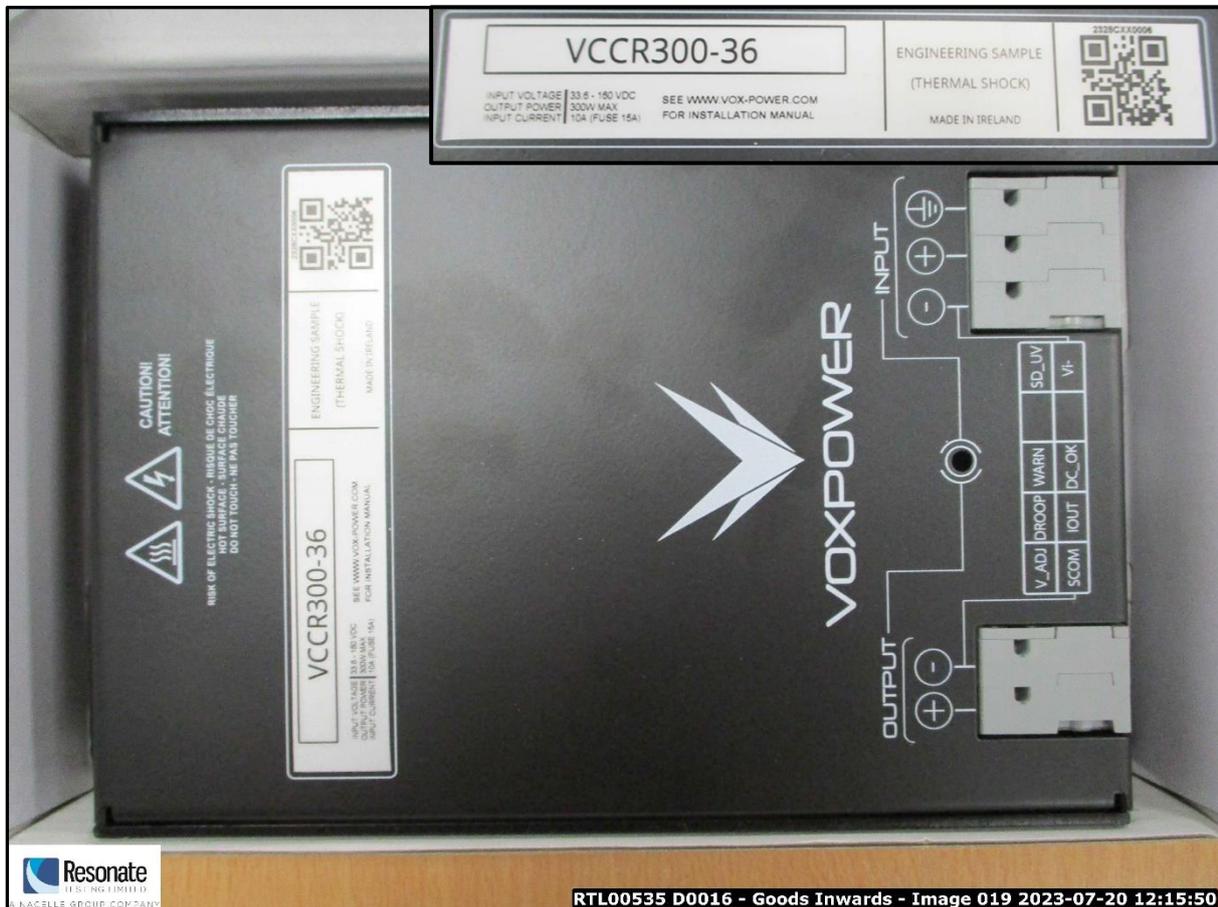
Figure 1: Test specimen - P/N: VCCR300-36, S/N: 2328CXX0006

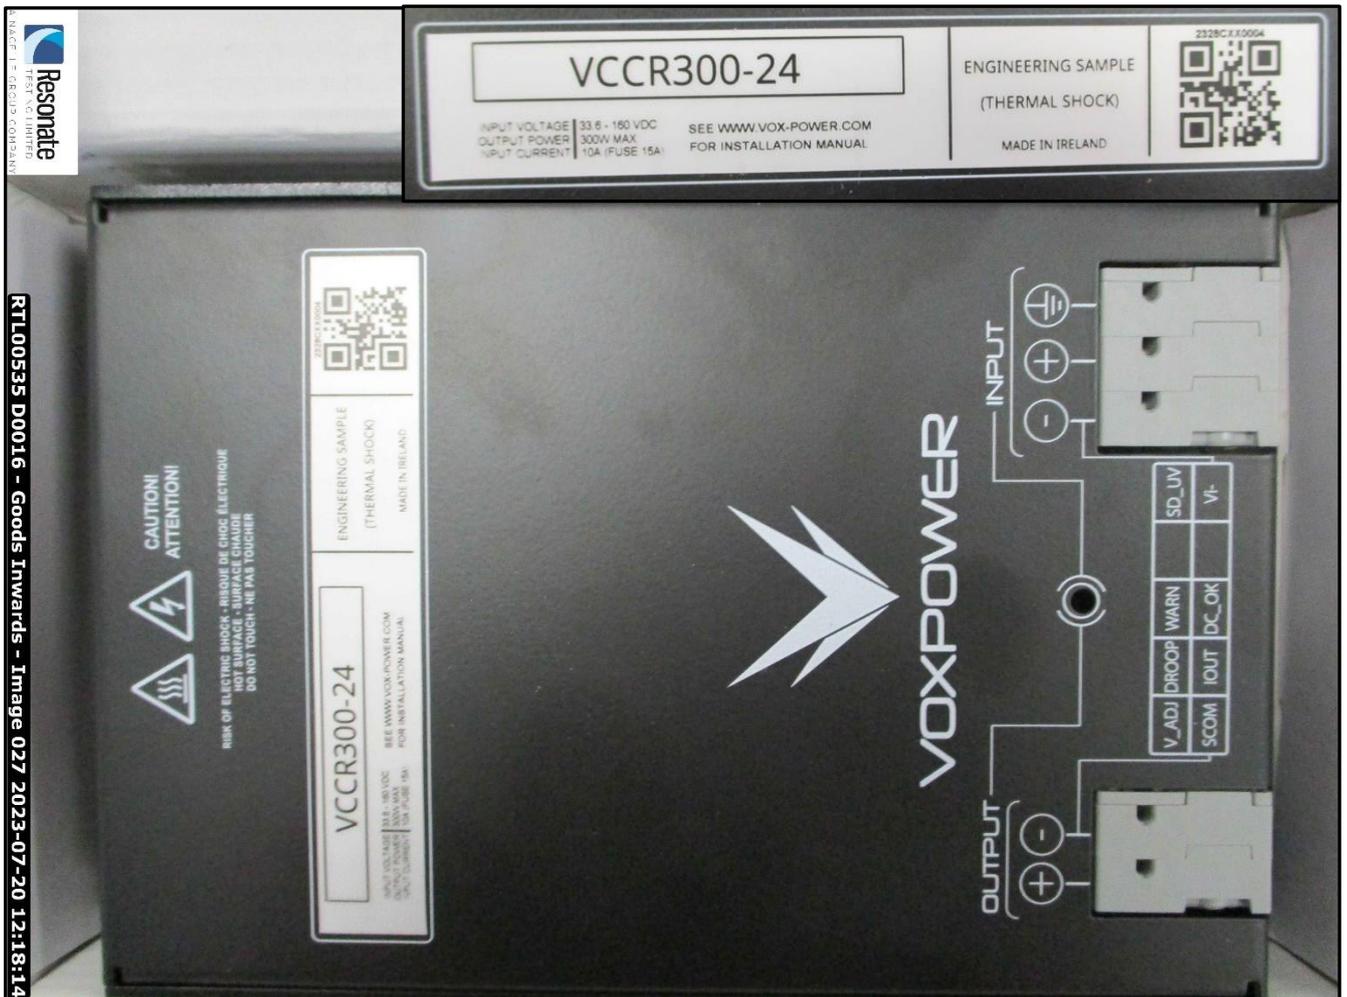
Figure 2: Test specimen - P/N: VCCR300-24, S/N: 2328CXX0004

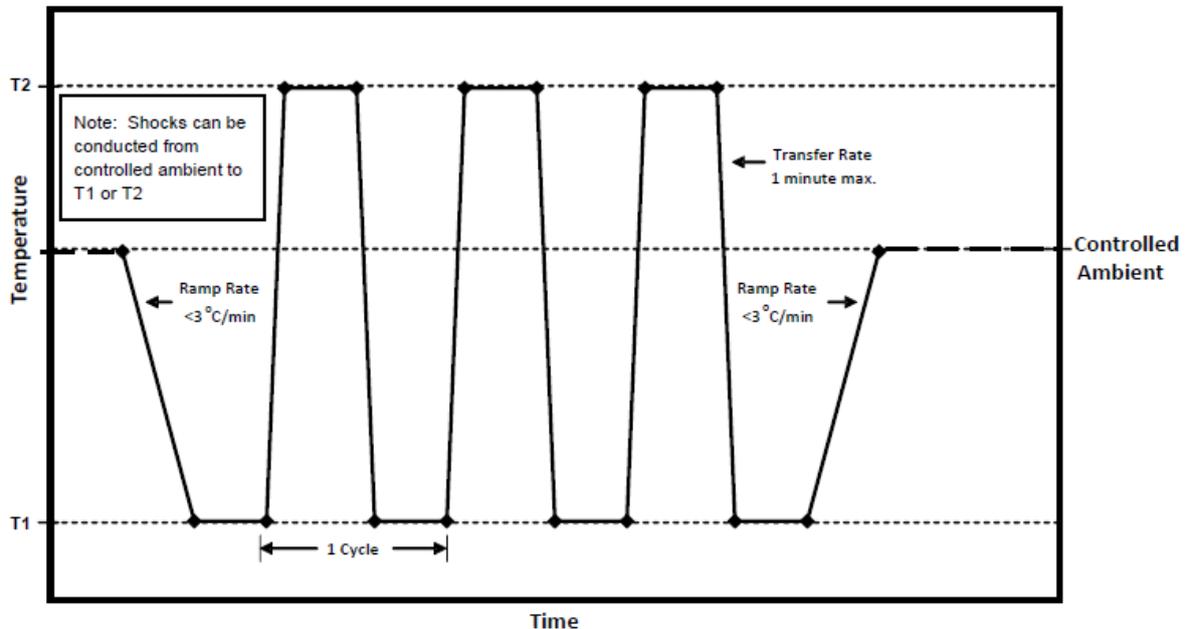
A thermal shock test was carried out in accordance with MIL-STD-810G: Method 503.5 Procedure I-C. the test specimens experienced 3 shock cycles at the required temperatures: T1 = -51°C and T2= 85°C

Figure 3: Temperature profile excerpt from MIL-STD-810G Method 503.5 Procedure I-C.

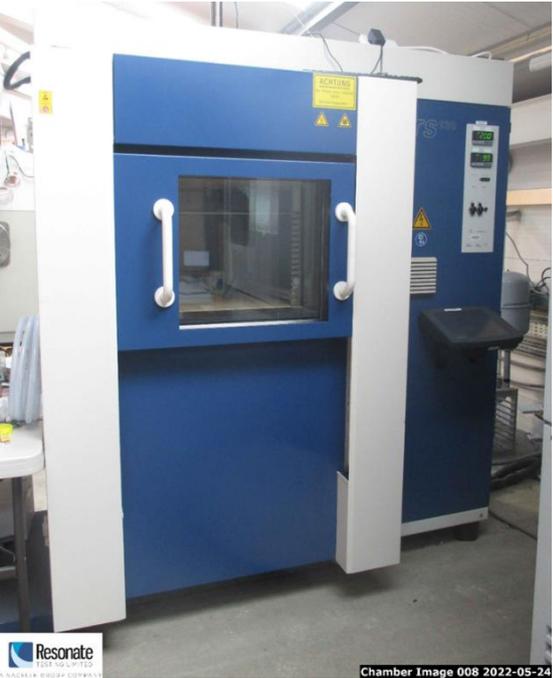
<p style="font-size: small; text-align: right;">Chamber Image 008 2022-05-24</p>	<b>Manufacturer:</b>	Weiss Technik
	<b>Model:</b>	TS 130
	<b>Temperature Range:</b>	Hot Chamber +60 to +220°C Cold Chamber -10 to -80°C
	<b>Transition Time:</b>	9 seconds
	<b>Serial No:</b>	59226120750010
	<b>Resonate Asset No</b>	RA01043
	<b>Note:</b>

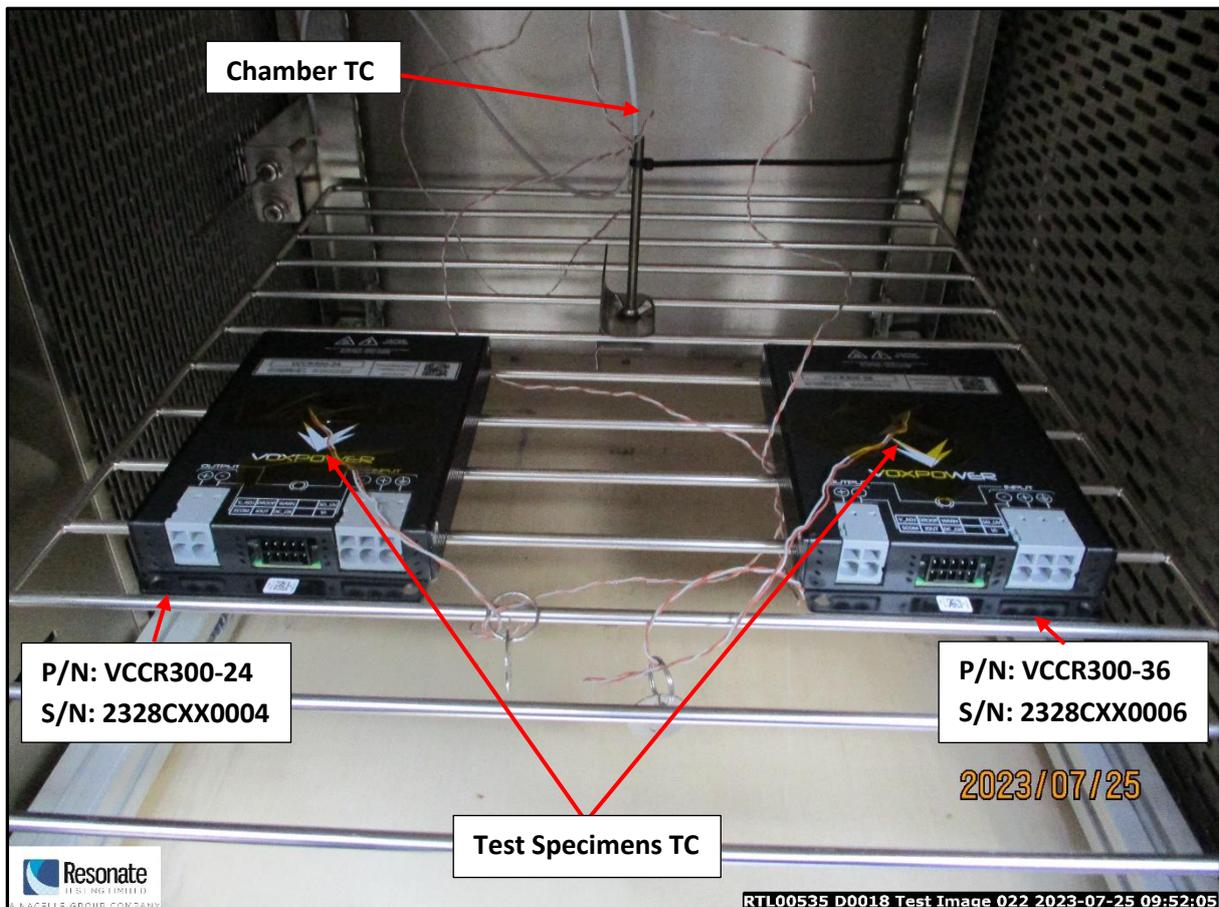
Figure 4. One type T thermocouple (TC) connected to a data logger, was used to monitor the chamber temperature throughout the test. Two type T thermocouples, connected to the same data logger, were used to monitor the test specimens' external temperature.

Figure 4: Units in chamber - Test setup

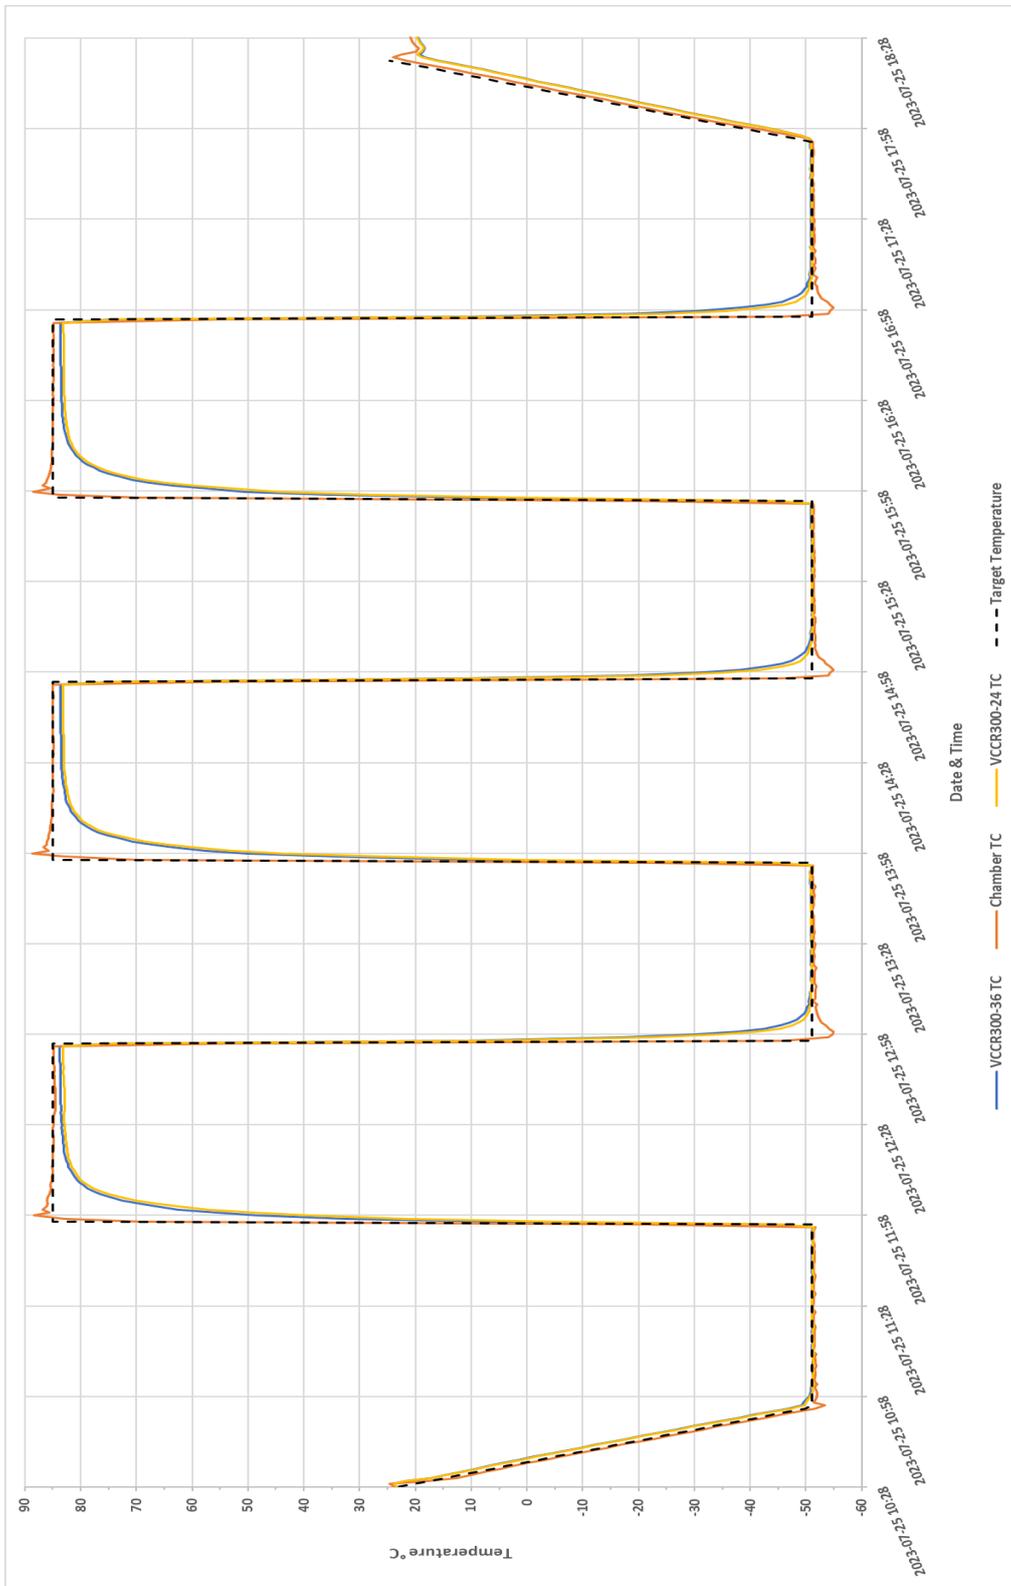
Figure 5 shows a plot of the temperature recorded during the test.

**Figure 5: Recorded Temperature plot**

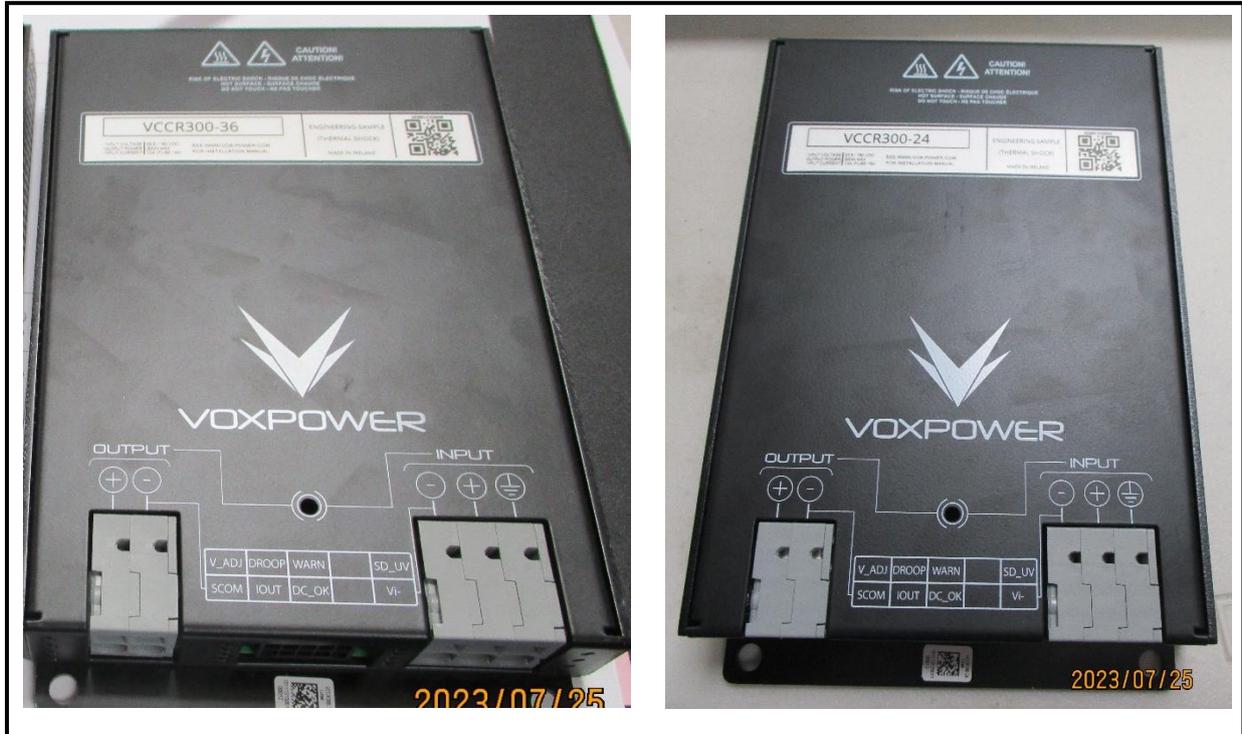
Figure 6 shows the test specimens post-test, once removed from the test chamber.

**Figure 6: Test specimens - Post test**
